# approach

THE NAVAL AVIATION SAFETY REVIEW

*vol 5 #8*

EMERGENCY  
**LANDINGS**  
ON FOAMED  
**RUNWAYS**

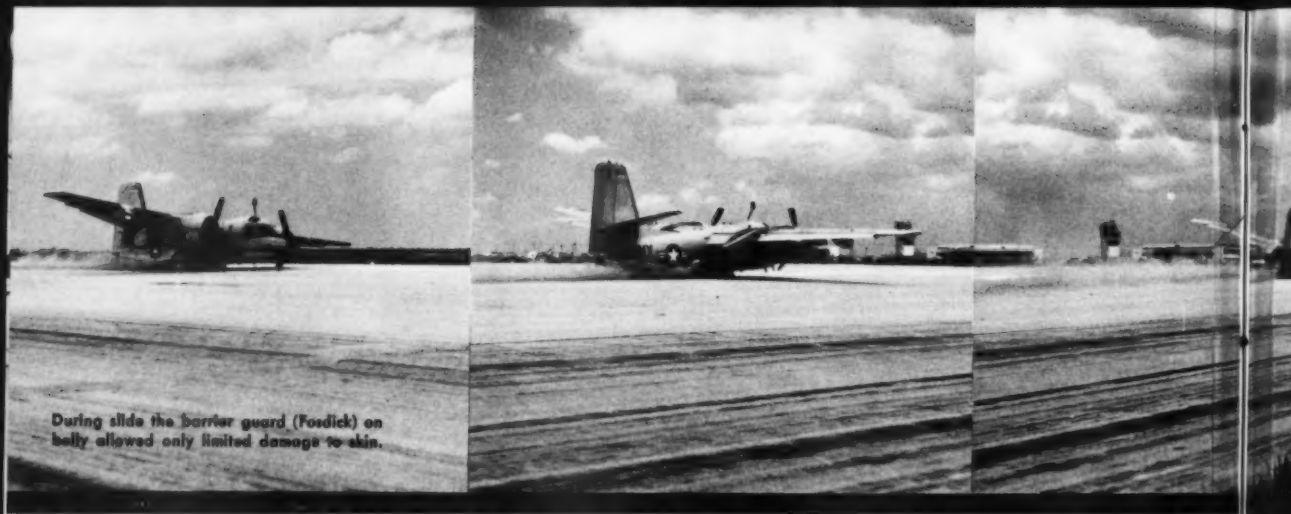
During slide the barrier guard (Fosdick) on belly allowed only limited damage to skin.

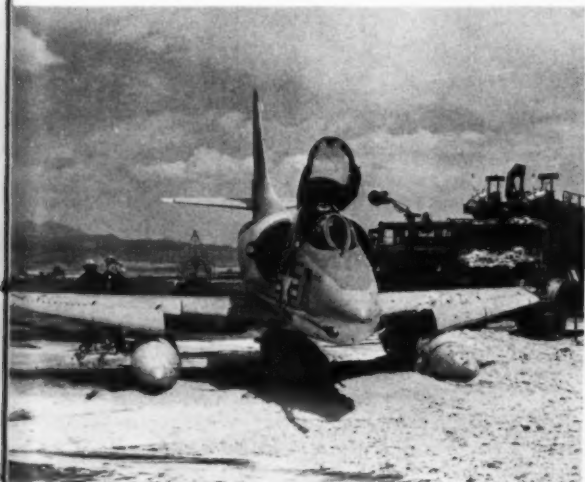
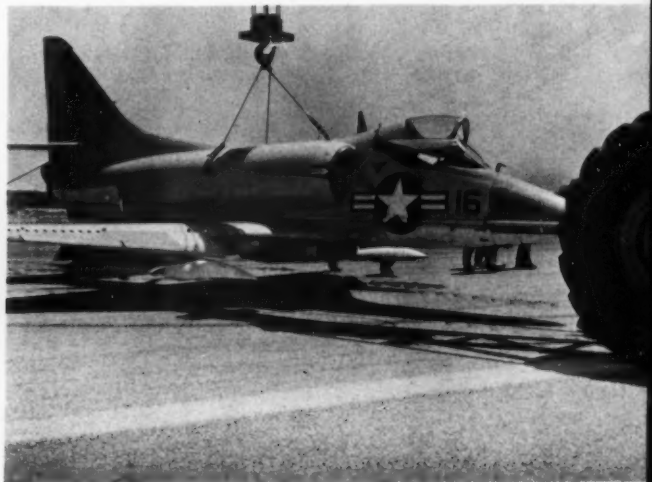
Absence of foam on runway does not necessarily mean fire will occur. A4D on left landed on prepared foam strip. No foam was used for aircraft at right. No fire was reported in either case.

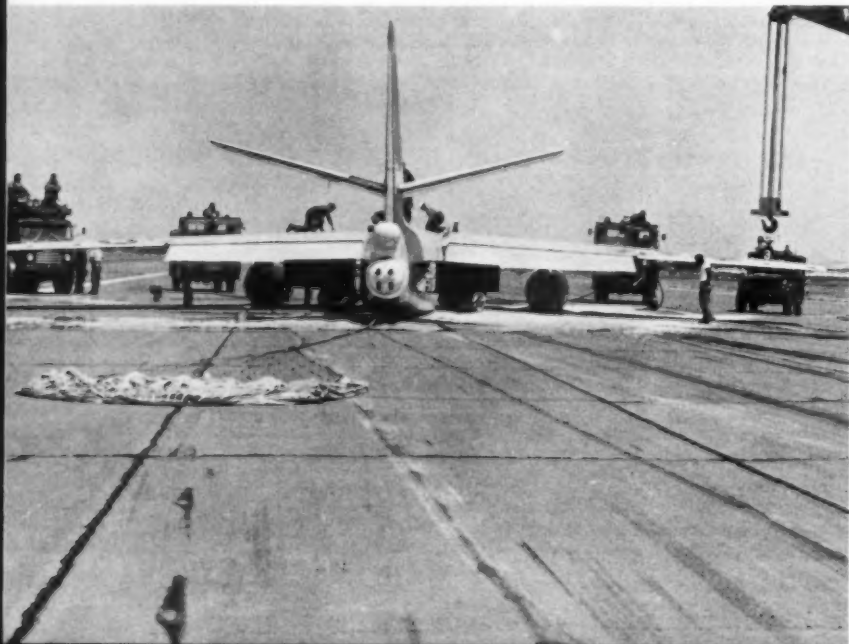
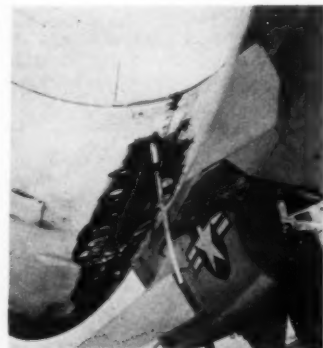
engines. Picture lower, right shows usual belly abrasion pattern of wheels-up landing.

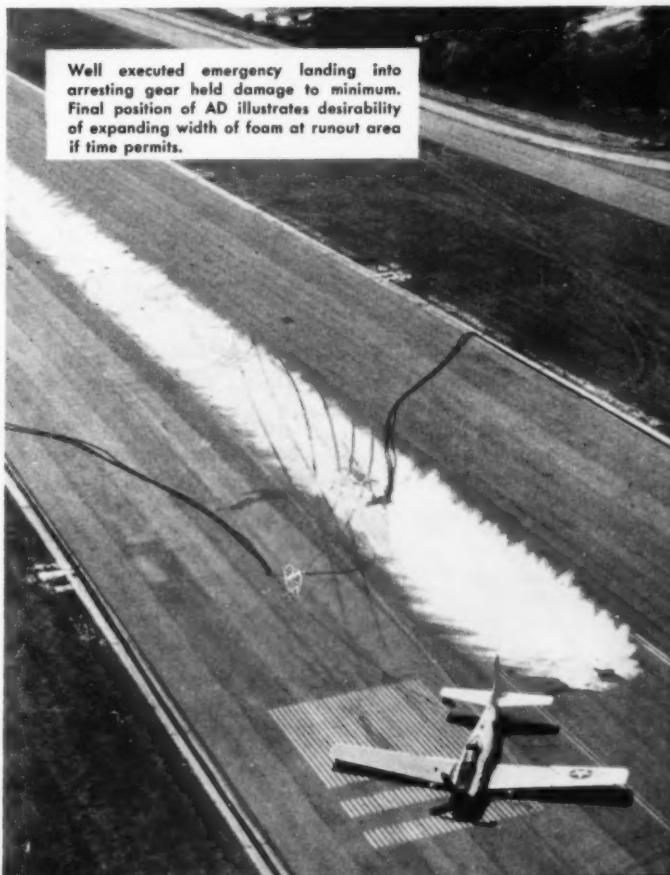
Well executed emergency landing into arresting gear held damage to minimum. Final position of AD illustrates desirability of expanding width of foam at runout area if time permits.

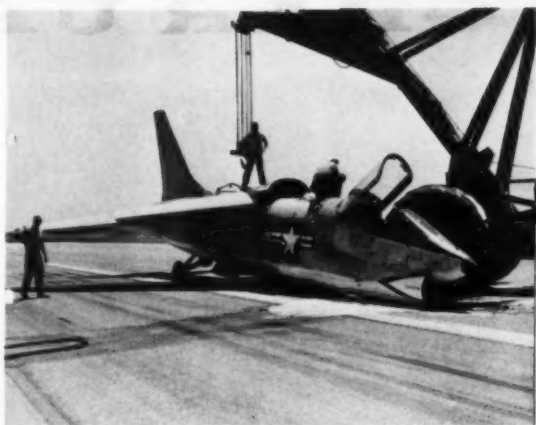
Damage to the F8U was confined to the intake duct and nose-wheel doors. Slight wheel braking was used to shorten the landing roll. In a similar case the runway had to be cleared quickly for low state jets and the crash crew towed the aircraft by the tailhook, with the nose dragging on the deck. Additional damage was done to the underside of the duct but experience has proved this method of removal is most expeditious when speed is important.

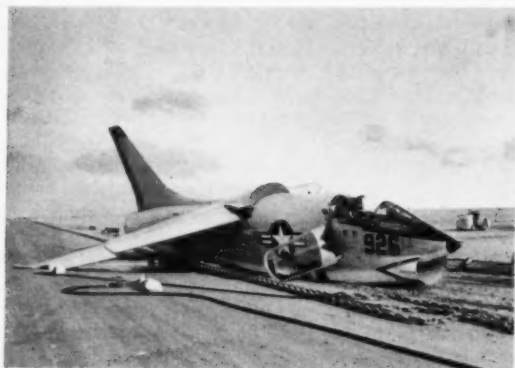
One main gear was retracted but this F8U emergency landing was complicated by a trailing nose wheel which collapsed and allowed extensive slide damage to forward fuselage. With the nose wheel extended, fuselage damage is sometimes limited to abraded skin on the aft section.

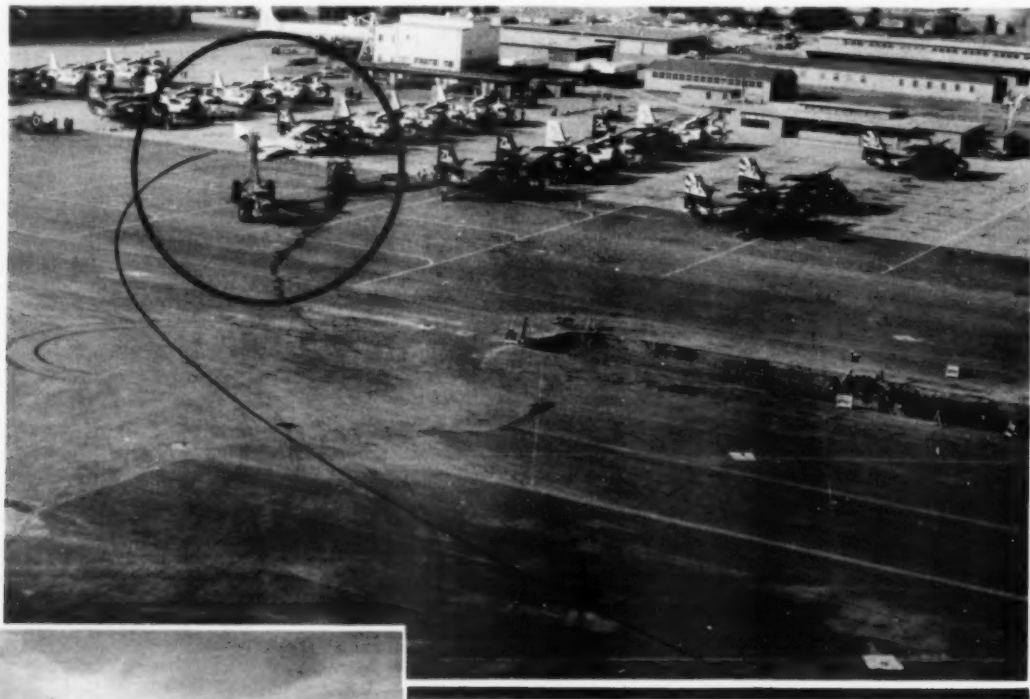
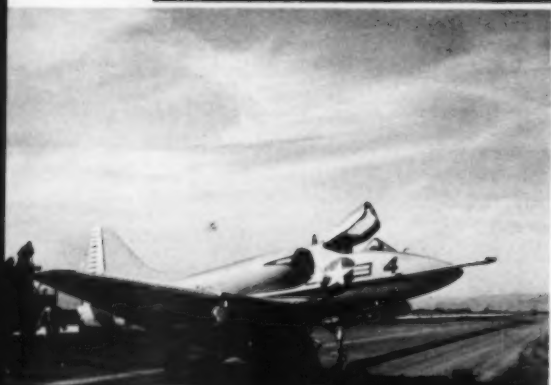
A4D at left used arresting gear; F9F in top photo (circled) did not. Both swerved in direction of disabled gear but arresting gear shortened and localized A4D rollout.

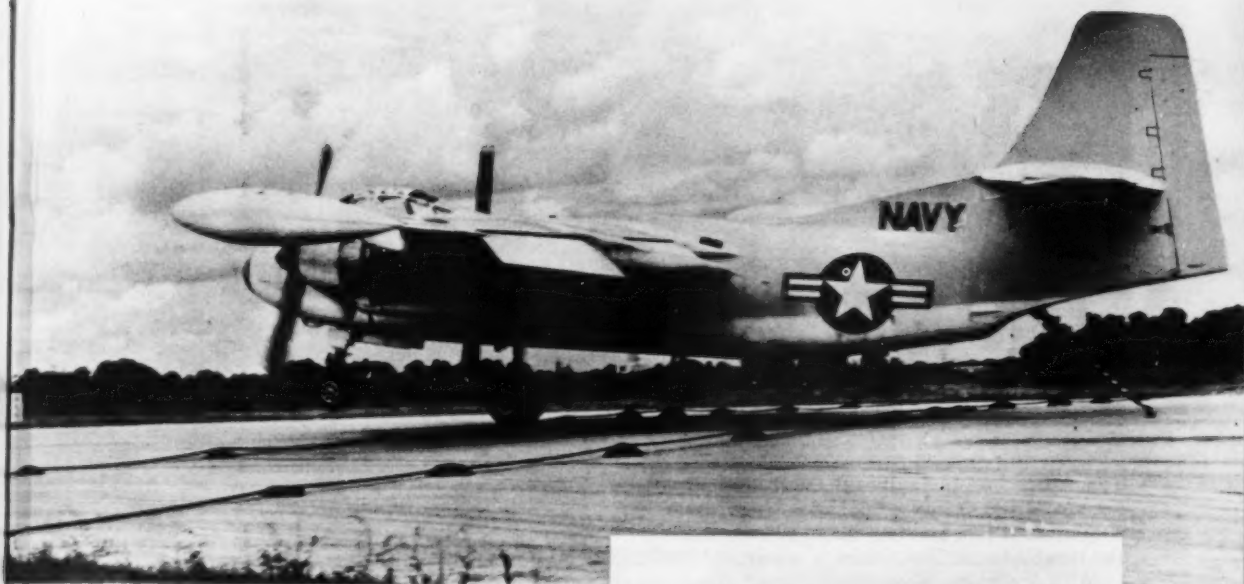
ABOVE: His right main gear unlocked, the pilot makes well-executed approach to emergency arresting gear. At right, AJ-2 is hooked and starts to sag as gear folds but, (right, below) foam strip is already passed as aircraft swerves.

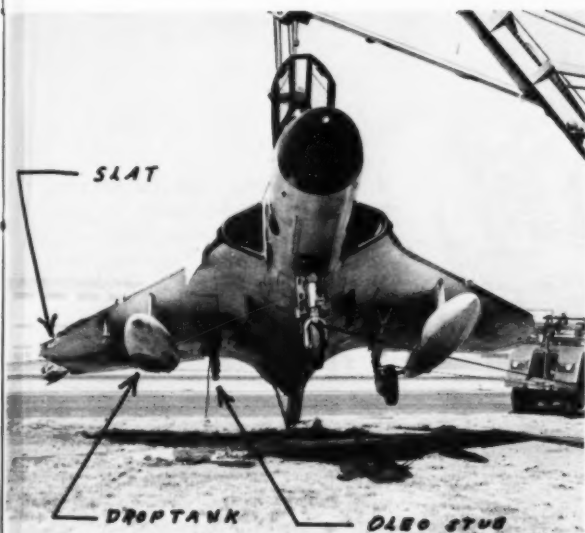
Given choice to eject or try emergency landing when wheel assembly broke off, pilot used field arresting gear and foamed runway. Damage to slat occurred on attempted CV landing.

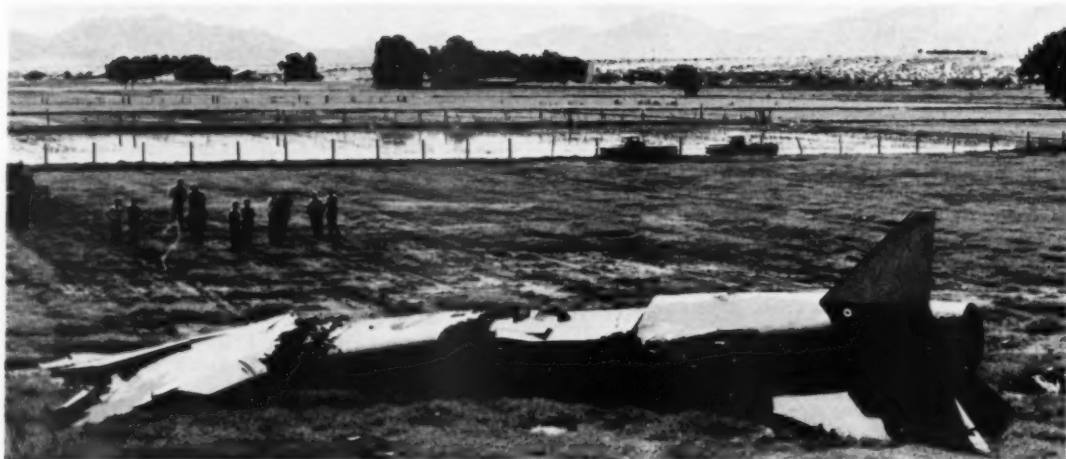
After flameout the pilot successfully ejected at less than 400'; his F8U continued on flight path for about 1250' before impact with the ground.
